ROCK SLOPE FAILURE BLOCKS AND THEIR RELATION TO
TECTONIC ACTIVITY: A CASE STUDY IN 3B HIGHWAY, XUATHOA
AREA, BACKAN PROVINCE, VIETNAM

Phi Truong Thanh* Phi Hong Thinh** and Nguyen Viet Ha***
*Hanoi University of Natural Resources and Environment, Hanoi, Vietnam
**University of Transport and Communications, Hanoi, Viet Nam
***Hanoi University of Mining and Geology, Hanoi, Viet Nam
*Corresponding author: thanhgislab@gmail.com

ABSTRACT

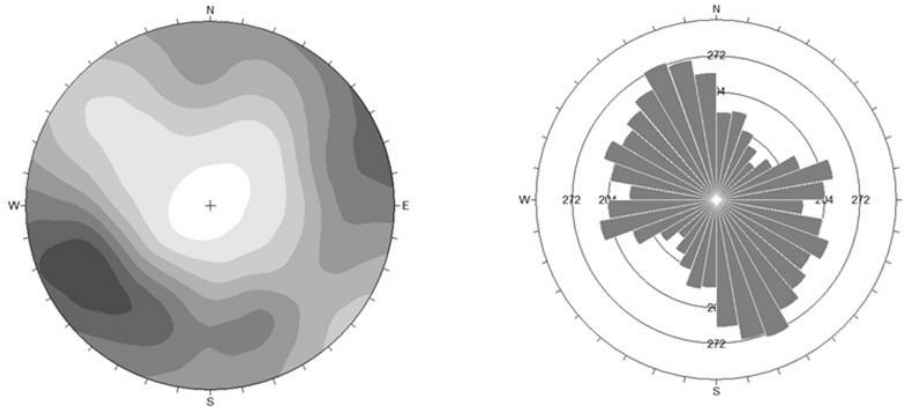
Diagram (4): The contour graph and rose graph of 3813 fractures at 33 survey sites along 3B highway in Xuathoa, Backan province, Vietnam.

The failure blocks on rock slope surfaces are formed by the intersection of fractures, faults in different directions and rock slope surfaces. The fractures, faults are the result of tectonic activities in the earth's crust. Initially, the rock blocks are formed by the intersection among fractures in steady status; after being excavated, they lose their equilibrium status and can slide on the rock slope surface, causing plane failure, wedge failure or toppling failure. The statistical data in the study area showed that the fracture orientations, which collected at survey sites developed in three main directions: E-W, NW-SE, N-S (Diag. 4).

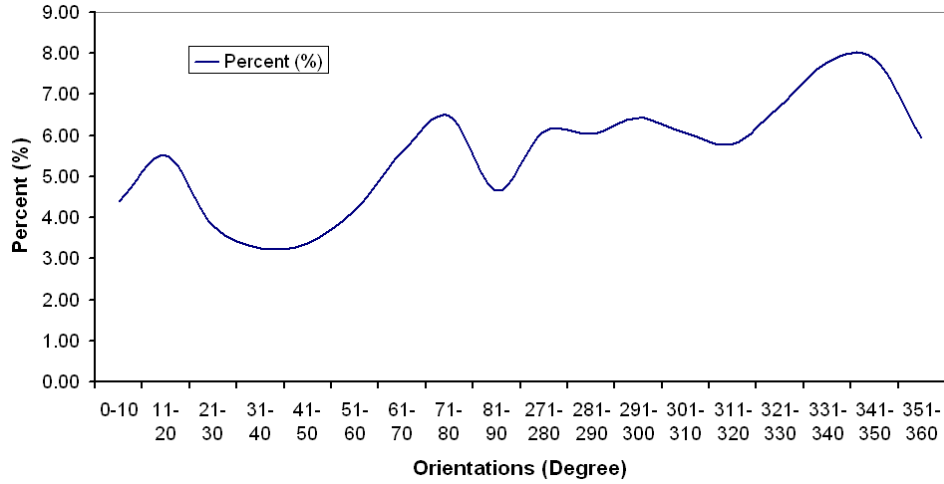
Diagram (5): The graph of percentage value of the fracture direction of the total survey sites along 3B highway in Xuathoa area, Backan province, Vietnam.

The percentage value of fracture direction of the total survey sites is recorded in Table (5) and Diagram (5).
